Reference: Hazardous Materials Survey Report - Addendum
Newberry Square Shopping Center
1824-1872 Wilson Road
Newberry, South Carolina
S&ME Project No. 1614-11-473

HAZARDOUS MATERIALS
SURVEY REPORT ADDENDUM

NEWBERRY SQUARE
1824-1872 WILSON ROAD
NEWBERRY, SOUTH CAROLINA
S&ME Project No. 1614-11-473

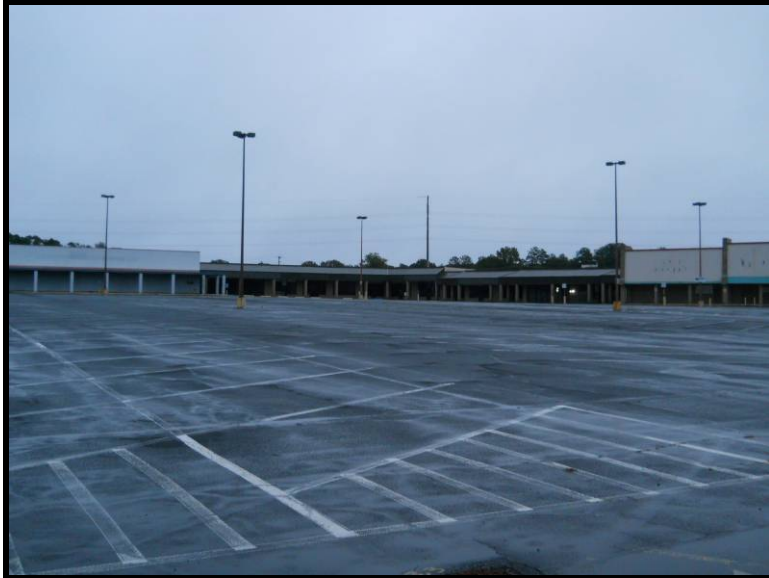
1 The subject building as seen looking roughly north from Wilson Road. The assessment did not include the former Winn-Dixie or Wal-Mart stores located at either end of the shopping center.

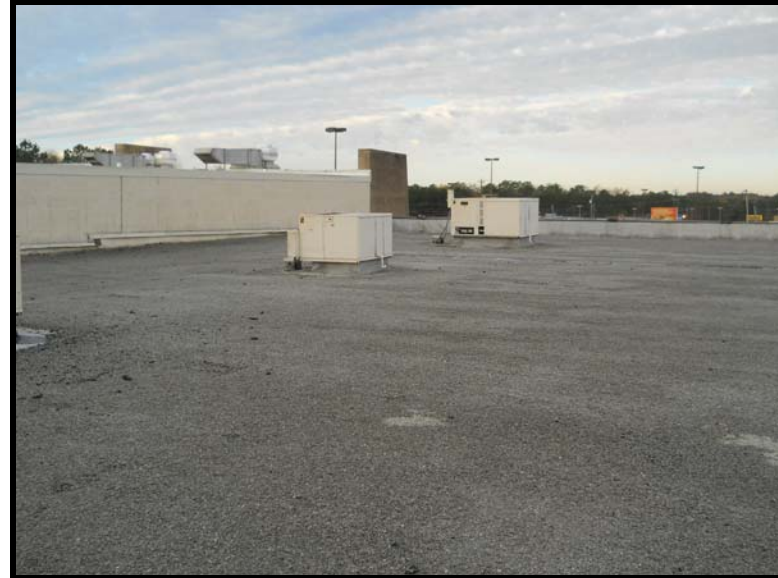
2 The roof of the former Cato Store (Store 1824).

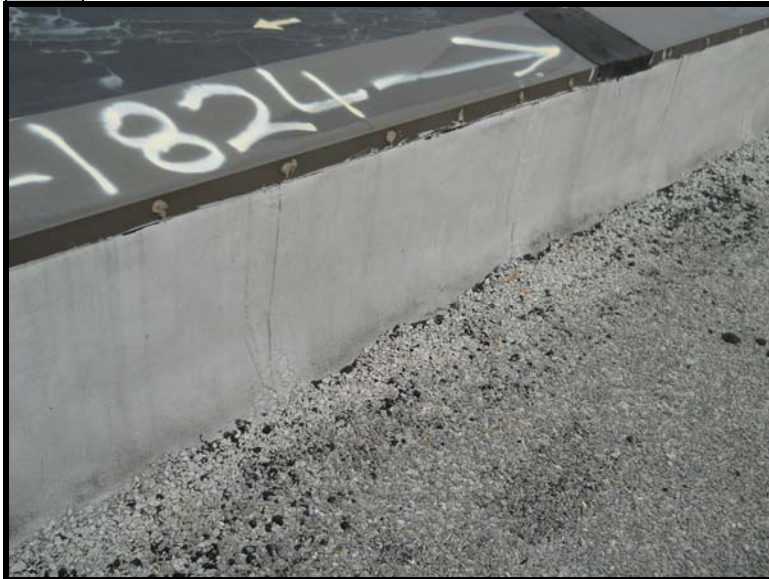
- *Silver Paint* (2% chrysotile) located on the bituminous flashing on the front parapet of Stores 1824 through 1844 and Stores 1856 through 1872. The silver paint is also present on the bituminous flashing under the roof-mounted air conditioning units. The estimated quantity is approximately 950 square feet – Refer to Photographs 3, 4, 6 & 7.

3 The silver paint located on the front parapet of most of the Stores tested positive for asbestos (2% chrysotile).

The EPA and SCDHEC require proper removal and disposal of ACMs that will be destructively affected by demolition activities, therefore we recommend the identified ACMs be properly removed and disposed by a qualified contractor licensed by SCDHEC, Asbestos Section, prior to the future renovation or demolition activities. If additional suspect materials are discovered during the planned renovation activities, bulk samples must be collected by a SCDHEC licensed Inspector or Management Planner and analyzed for asbestos content.

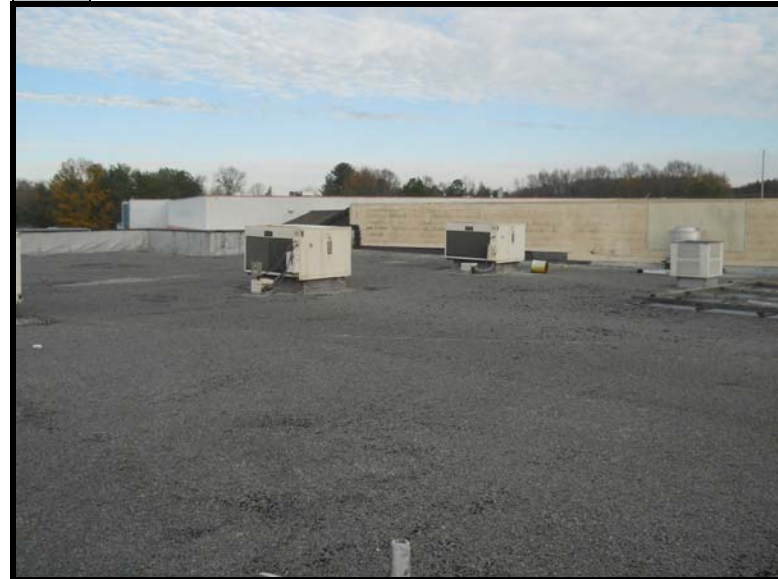
4 The roof over Stores 1840 and 1844. The silver paint located at the base of the A/C units tested positive for asbestos (2% chrysotile).

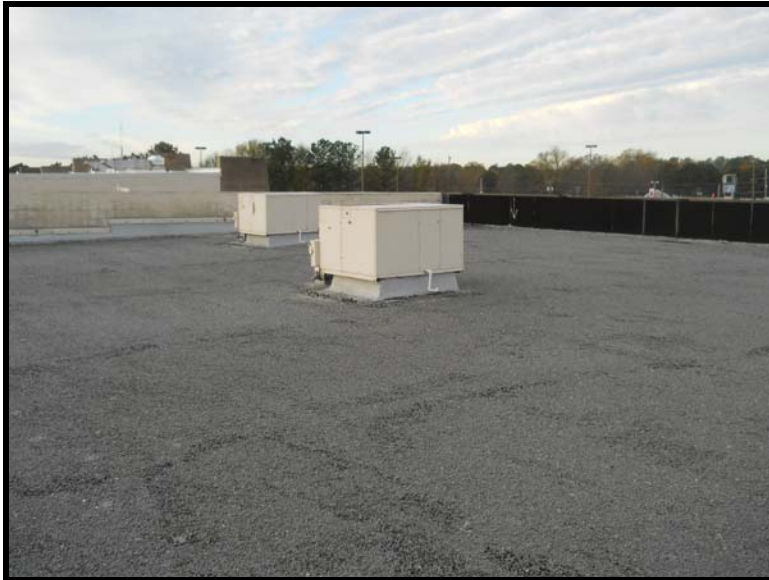
5 The roof over Stores 1848 and 1852. The black flashing on the front parapet of these stores did not test positive for asbestos.

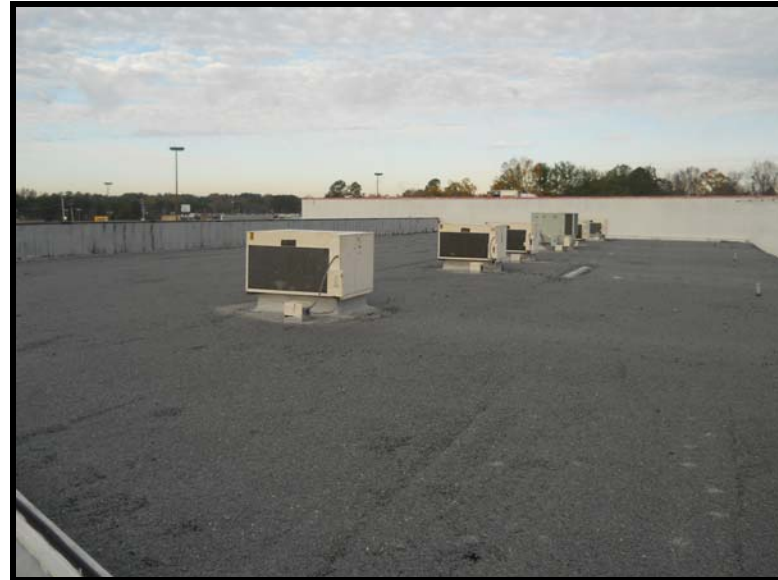
6 The roofing system over Stores 1856 through 1872. The silver paint located on the front parapet and under the A/C units tested positive for asbestos (2% chrysotile).

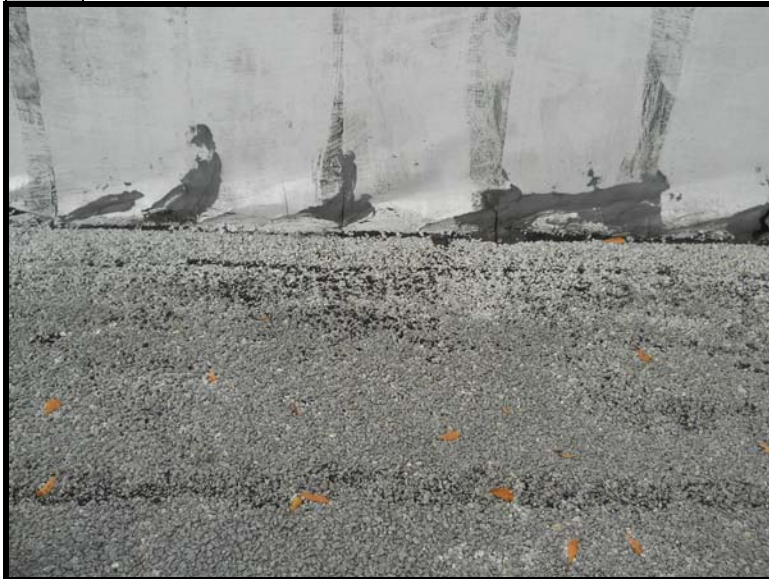
7 The roof and parapet at the front of Store 1872. The silver paint located on the front parapet tested positive for asbestos (2% chrysotile).
